ECOLOGY AND ENVIRONMENT, INC.,

MEMORANDUM

Sampling inspection at U.S. Gypsum, Corsicana, TX. (TX10022) TDD# R06-8507-20

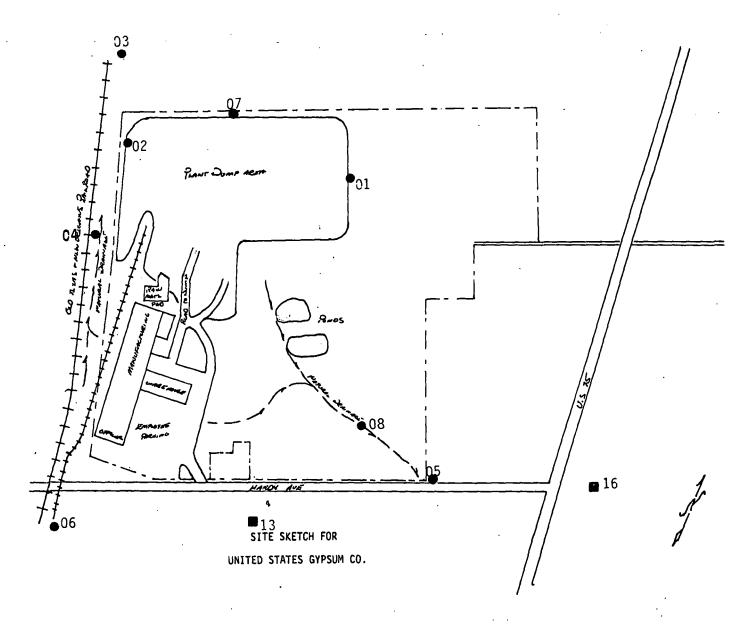
Table 1 lists the sampling locations and a description of their proximity to Stations 01-08 were sampled on December 17, 1984 and Stations 10-16 were sampled on August 27, 1985. The stations are also shown on the site sketch included in this report.

• - 12/17/84 sampling

a - 8/27/25 sampling

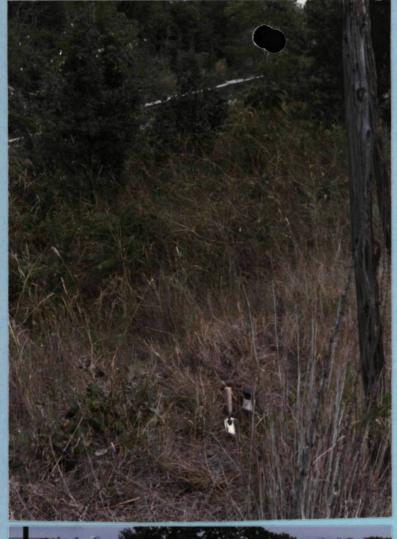
Photographer / Witness
Chapman/Verhalen
Date / Time / Direction
8-27-85/1110/Facing North comments: Station 12
Comments: Station 12
Photographer / Witness
Date / Time / Direction
Comments:
Photographon / Witness
Photographer / Witness
Chapman/Verhalen
Date / Time / Direction
8-27-85/1130/Facing North Comments: Station 13
Comments: Station 13

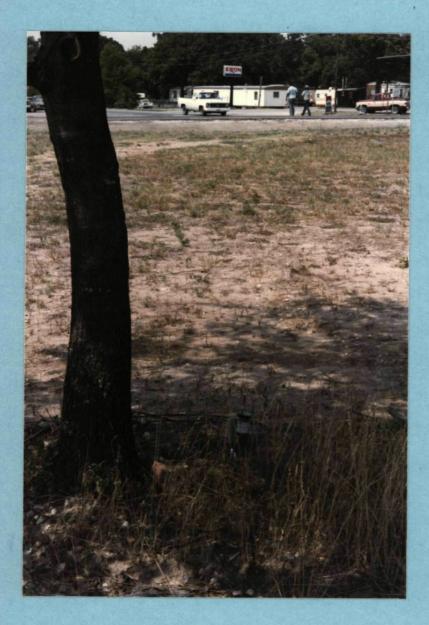
Date / Time / Direction
Comments:
Photographer / Witness
Chapman / Verhalen
Date / Time / Direction
8-27-85/1210/ Facing West
Comments: Station 16
Commerces. 3724122 /6
Photographer / Witness
Date / Time / Direction
Comments:
